Incident

Failure of a black liquor tank in a paper mill

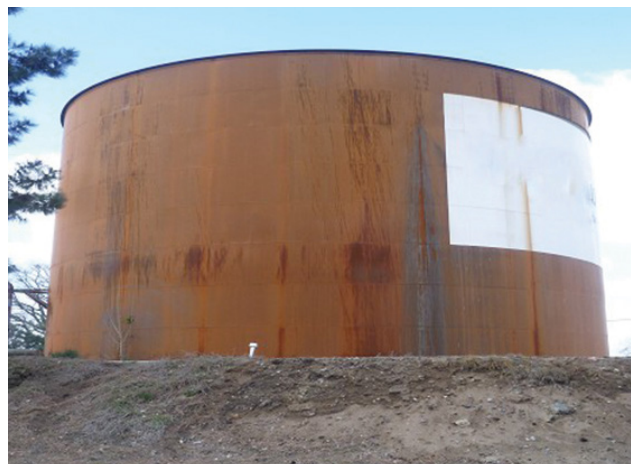
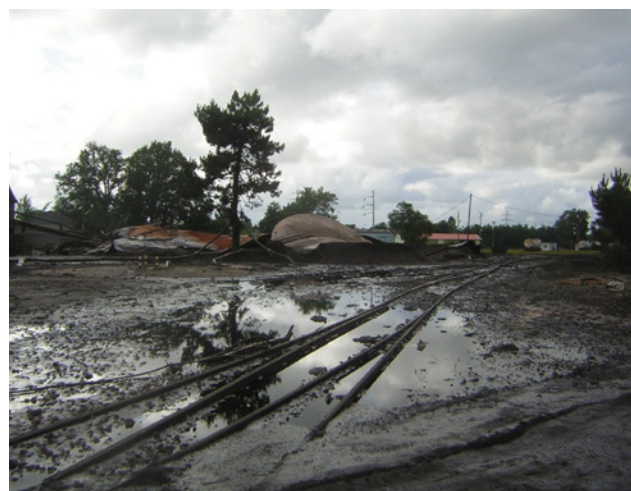
Photographs of the tank taken before and after the accident - Source: DREAL Aquitaine (Environmental Agency)

A complete rupture of the RC15 tank sidewall (a vertical zip tear) as well as on both the top joint (beneath the lid) and bottom joint (base of the chest) caused 4,100 m³ of hot (80°C) black liquor to spill. The wave effect (upto 10 m high) caused the collapse of most of the retaining bund walls as well as damage to other parts of the site (though without triggering a secondary accident).

The exact accident causes are not yet known. The expert commissioned by the factory operator reported that an instantaneous pressure surge caused the tank damage, but the origin of the pressure surge was not determined.

The operator has undertaken works to replace both 5,000 m³ black liquor tanks according to the following layout:

- reduction of storage volumes to 3,250 m³ and 3,275 m³ respectively, for a 35% decrease;
- use of stainless steel to improve corrosion resistance;
- introduction of corrosion test samples to identify any type of degradation;
- a shared reinforced concrete retention basin: with a volume corresponding to that of the tank with the largest capacity; designed to resist the wave effect and fitted with an "anti-spill" rim to contain the product in case the shell-bottom joint breaks.
